[To be published in Scanning Electron Microscopy, 1981]

6  
Auger Electron Spectroscopy  
as Applied to the Study of the  
Fracture Behavior of Materials

10  
Michael Schmerling, Duane Finello and H.L. Marcus

Mechanical Engineering/  
Materials Science and Engineering  
The University of Texas  
Austin, Texas 78712

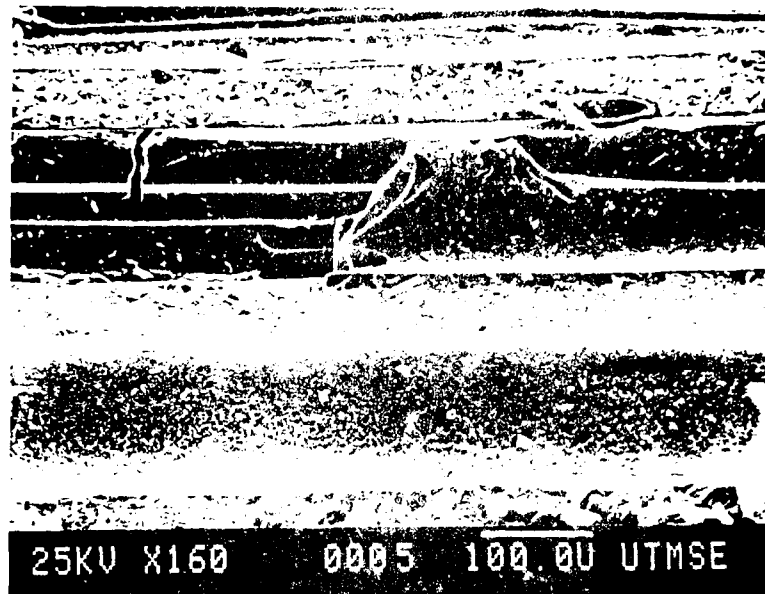
FIGURE 3 (a) Fracture surface of Ti-6Al-4V/SiC composite showing path through interface

In studies of Ti-6Al-4V matrix with  $B_4C/B$  or SiC fibers, fiber composites in the form of consolidated wires with the fiber axis in the plane of the plate were fractured inside of the AES vacuum system. The fracture paths, Figure 3, contain a large amount of interface and followed the fiber sides of the interface through the carbides as

determined from the characteristic carbon Auger derivative peaks. Careful peak shape studies can help determine which carbide, such as Ti or Si carbides in the SiC fiber composite, is present. Carbides and oxides near the SiC fibers and borides near the  $B_4C/B$  fibers along with S and Cl impurities were localized at the interface as determined by sputter profiling. The brittle compounds associated with these elements and their poor bonding to the adjoining phases created a layer that resulted in the lowest energy fracture path.

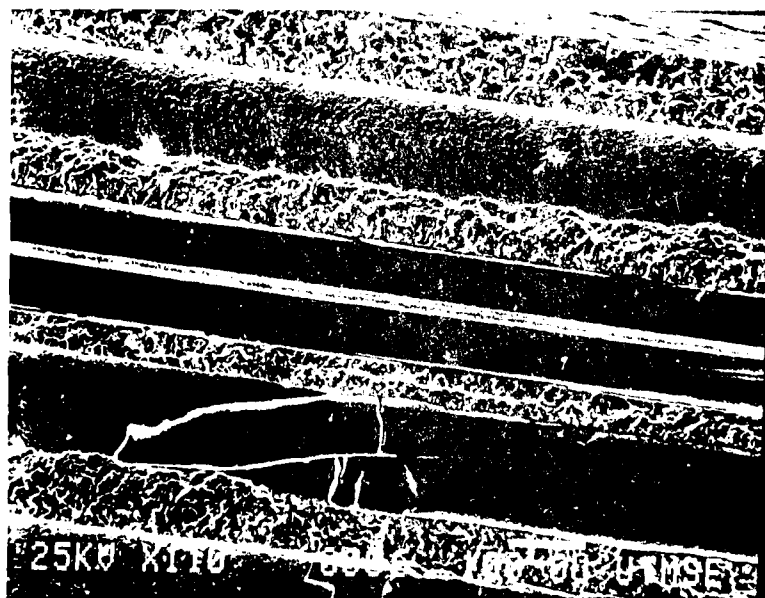
FIGURE 3 (b) Fracture surface of Ti-6Al-4V/B<sub>4</sub>C/B composite
